CORRECTION OF UNEVEN GRINDING PRESSURE ON 680 VALVE GRINDING MACHINE

SIOUX TOOLS INC.
SIOUX CITY, IOWA, U.S.A. 51102

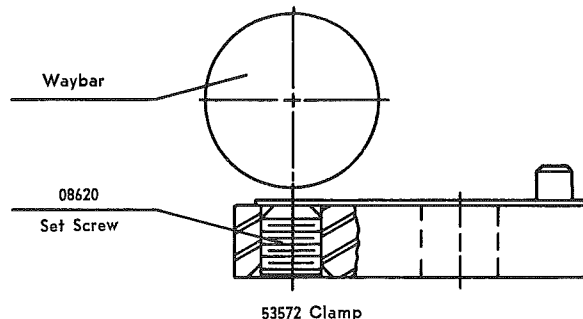
When pressure is heavier in one direction than the other while dressing the grinding wheel or grinding a valve, it is most generally caused by wear on the carriage plate waybars (24201), improper adjustment of the clamps (53572) or lack of lubrication. See pages 1, 14, and 16 in the Parts List.

The proper adjustment of the clamps (53572) is very important. If one or both of the front clamps are too tight, the pressure on the grinding wheel will be heavier when moving the carriage plate to the left. If the rear clamp is too tight, the pressure will be heavier when moving the carriage plate to the right.

Loosen the three (08620) set screws. There are two (53572) clamps on the front waybar and one on the rear.

1. Screw the rear set screw in until contact is made with the waybar, then unscrew it at least $\frac{1}{4}$ turn.
2. Tighten one front set screw at a time while moving the carriage plate. Contact with the waybar should be very light so that the traverse action will remain smooth. Repeat this adjustment with the remaining front clamp.

Check grinding pressure by dressing the wheel with a light, slow cut of the diamond. The first cut should show a bright steady spark. Without advancing the wheel or diamond, bring the diamond back across the wheel. A faint but steady spark should be noticeable and subsequent passes over the wheel should not remove any material until the diamond is again advanced.
